*Airfield Damage Repair Modernization Program*

## **AM2 Modified 2-1 Lay Pattern Evaluation under F-15E Traffic**

August 2015

Final report

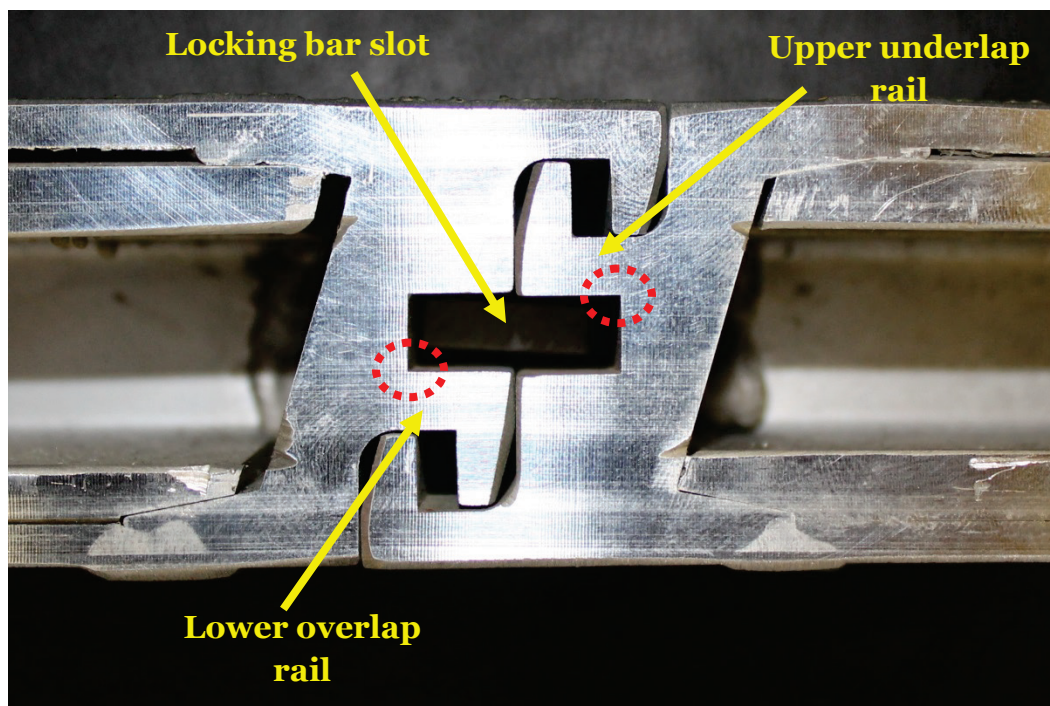
Figure 2. Corners with fillet omitted, as indicated by the dotted circles.

After completion of the test program listed in Table 1, a thorough investigation of both the subgrade and the mat revealed that the manufacturer’s drawing of the extrusion die for the AM2 end connector inadvertently omitted filleted corners in the locking bar channel, at the interface with the smallest cross-sectional area of the rail (Figure 2). Several modeling efforts showed these corners were areas of high stress concentration that eventually caused cracking along the upper underlap or lower overlap rails, which was damage commonly reported by Rushing and Tingle (2007), Rushing and Torres (2007), Rushing et al. (2008), Rushing and Mason (2008), and Garcia and Rushing (2013). An example of crack initiation at one of the corners is shown in Figure 3.

The die was recently corrected after an unknown period of producing the non-filleted design. Researchers questioned whether this fillet omission might have affected the performance of AM2 throughout the NAVAIR and AFCEC test program. Based on modeling results, it was assumed that a filleted corner would reduce stress concentrations at these locations and provide better fatigue life of the rails. Therefore, AFCEC sponsored an evaluation to quantify the difference in performance (if any) between an AM2 production without the filleted corners in the locking bar channel and a production lot with the filleted corners. Each test item was installed in the brickwork pattern. The results showed a significant increase in the performance life with the filleted corners. Further details of this test are reported by Garcia et al. (in preparation).

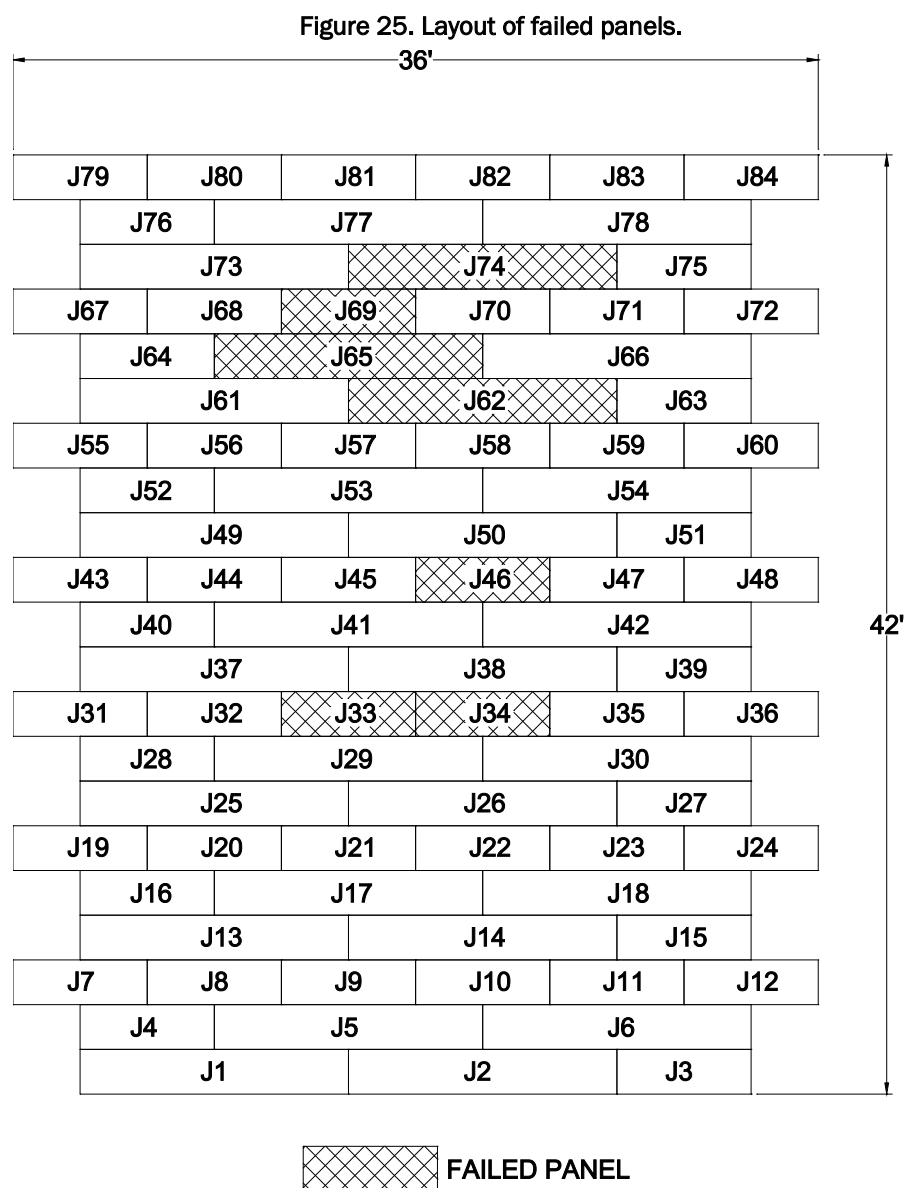
Trafficking began on 27 October 2014. Figure 25 shows the layout of the failed panels as noted by visual observation in the test section. The accumulation of mat damage and mat breakage throughout trafficking and the damage noted after removing panels from the subgrade surface are summarized in Table 8.

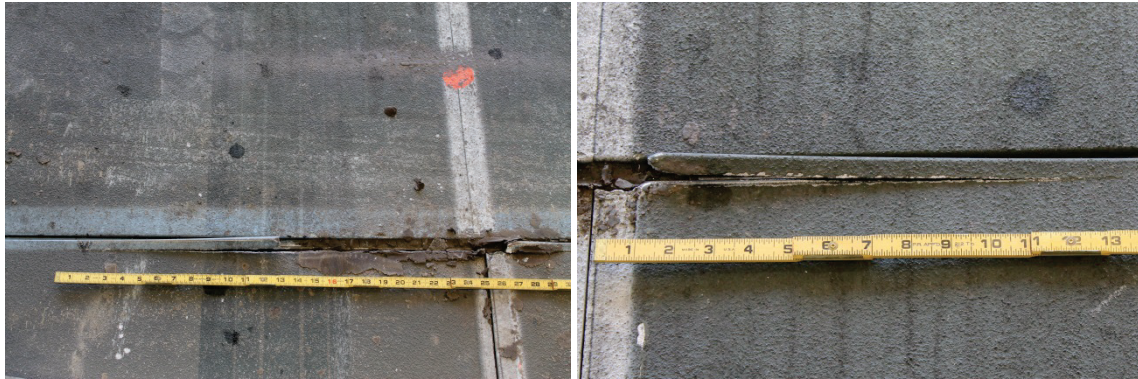
Figure 26. Top skin tear on J46 (left) and J33 (right).

The most common failure mechanisms were top skin tearing greater than 10 in. and core crushing. The most common damage was minor stop skin tearing and corner curls. Top skin tears occurred in panels with their end connector in the traffic area. A top skin tear typically began at (or near) the south edge of the end connector weld and propagated along the top flange of the female hinge. Examples are shown in Figure 26. If a top skin tear reached a point where it was posing a risk to the load cart tire, it was cut for maintenance. Skin tears greater than 10 in. were difficult to maintain, and traffic had to be stopped frequently for maintenance. Therefore, if the length of the top skin tear reached more than 10 in., the panel was considered failed. Top skin corner curls occurred at the south corner of panels with their end connector along the centerline. They occurred before top skin tearing developed and were hammered down if they posed a risk to the tire.

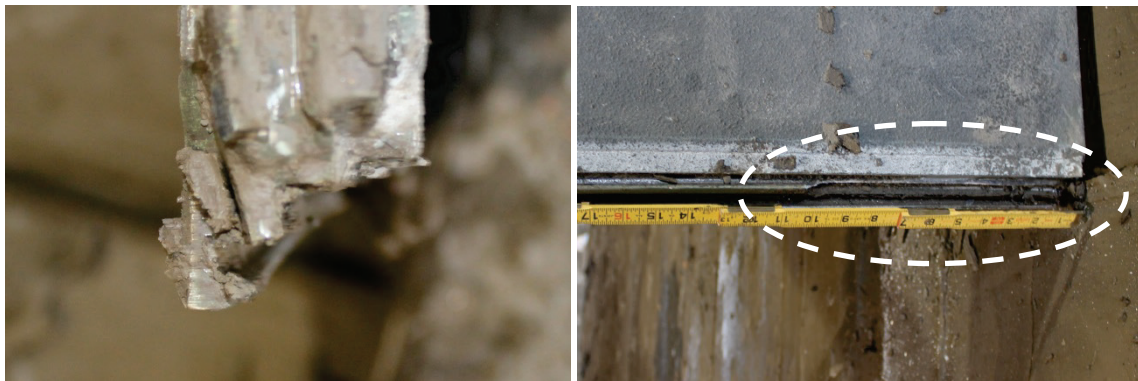
Figure 27. Upper underlap rail breakage at J46 (left) and J70 (right).

Four panels had breakage at the end connector: two at the upper underlap rail and two at the lower overlap rail. When a rail failure occurred, separation was noted at the adjoining panels as the load cart passed over the joint. Upper underlap rail failure was confirmed when a crack could be seen at the rail from the surface. Examples are shown in Figures 27 and 28. J70 was partially broken at the upper underlap rail, and J9 was partially broken at the lower overlap rail (Figure 28), but the length of breakage in these two panels was 10 in. and 1.5 in., respectively. Since these lengths were less than half the length of the rails, J70 and J9 were not considered failed.

After 1,728 passes, the skin tear and the upper underlap rail failure at J46 were posing serious risks to the load cart tire. Since it was important to continue traffic until mat breakage failure was achieved, a metal plate was placed over J46 and J45 to bridge over the damaged area (Figure 29).

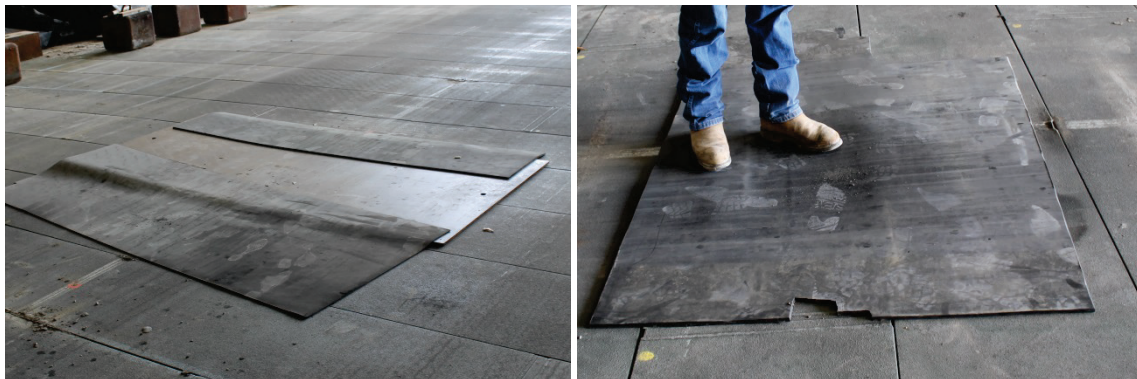
Figure 29. Metal plate placed on J46/J45 (left) and rubber mat placed on J74 (right).

Core crushing was documented in three panels. This failure mechanism is evident through dishing observed on the surface, as shown in Figure 30. Panel J74, which was the first to fail by core crushing, also sheared at the female hinge, creating a severe tire hazard. A rubber mat was placed over the panel (Figure 29) to cover the damaged area and to continue traffic.

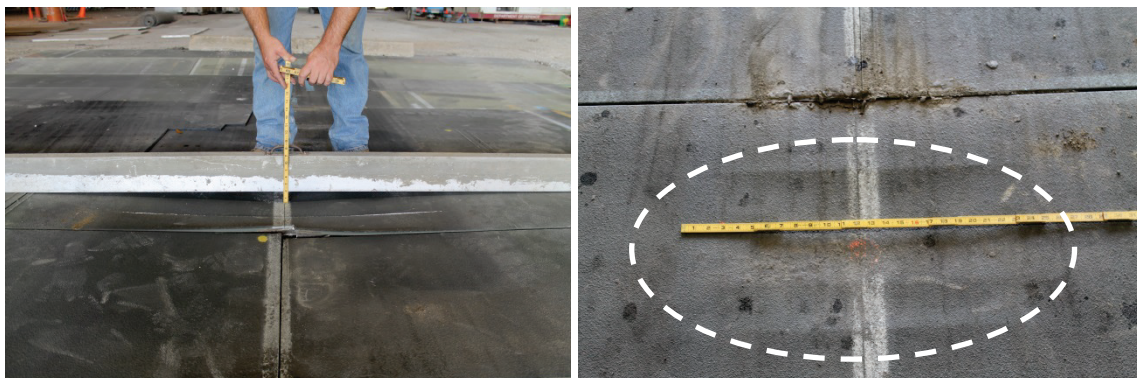
Figure 30. Core crushing in J74 (left) and J62 (right).

Core crushing occurred in three panels due to buckling of the vertical members in the mat core. Rushing and Tingle (2007) reported at least two panels to have failed by core damage in their testing. The initial sign of core crushing was dishing observed on the surface. As the panel structure continued to collapse with increasing load repetitions, the dished area became larger. Top and bottom skin cracking parallel to the vertical stiffeners were characteristics of this failure mechanism. Cracking developed because the skins could no longer accommodate the bending action of the load without the support from the stiffeners.

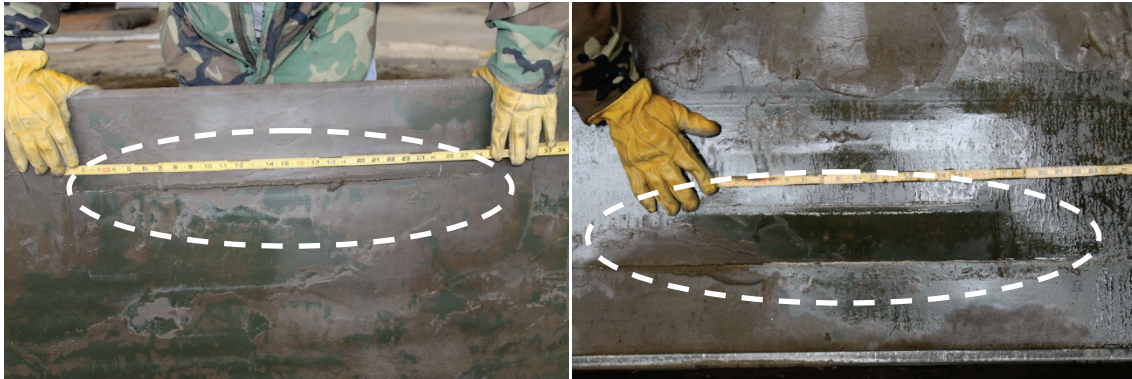
Figure 31. Cracks on bottom skin of J65 (left) and J62 (right).

Mat breakage failure was reached after 2,638 passes when 10.7 percent of the test item was documented as failed. Traffic was concluded after 2,850 passes, and the panels were removed from the test subgrade. After the panels were removed from the test section, panels where core crushing had occurred were noted to have cracks on the bottom skin (Figure 31).
